## B.25 Uganda - 2007 - Slow onset floods

### Case study:

Uganda - Katakwi and Amuria districts

Floods

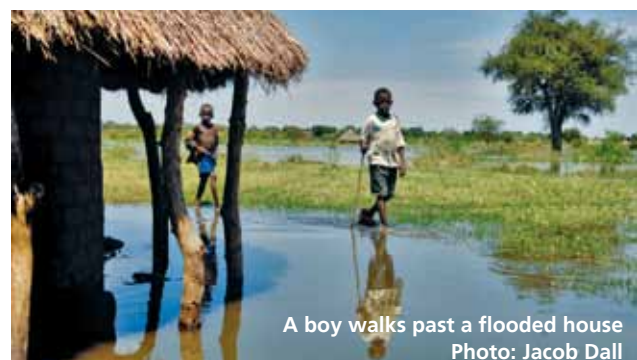
A boy walks past a flooded house  
Photo: Jacob Dall

Heavy rains in the East of Uganda caused slow-onset floods that damaged houses in the camps and destroyed crops in the fields.

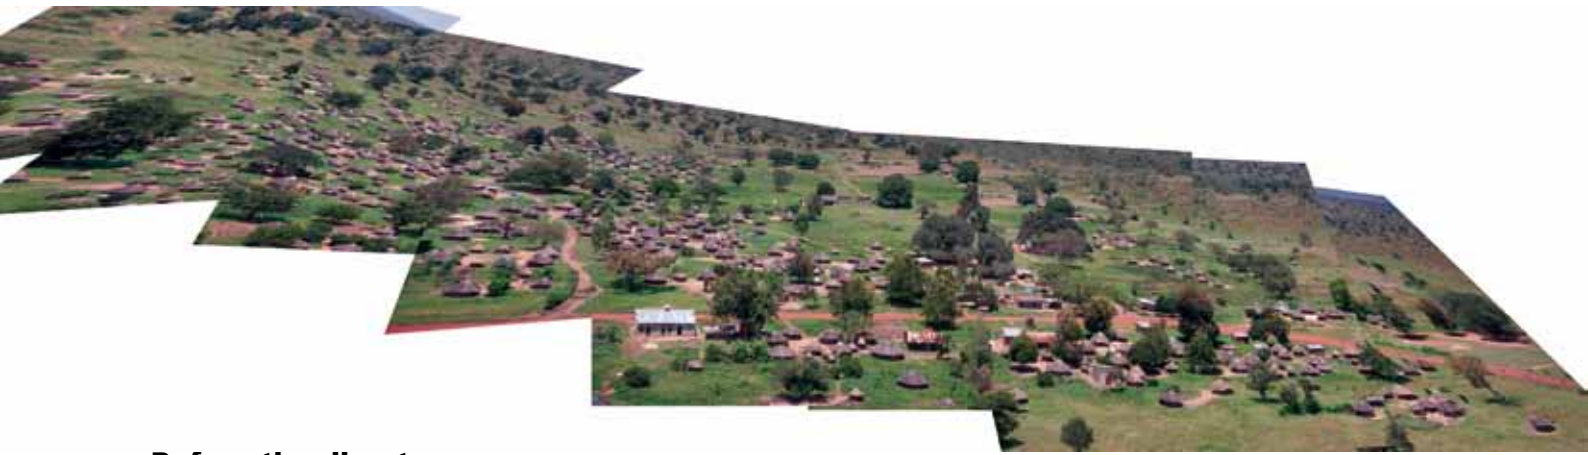
**View of a village after the floods showing the traditional circular shelters.**

The traditional local shelter design is a round mud hut with a thatched roof.

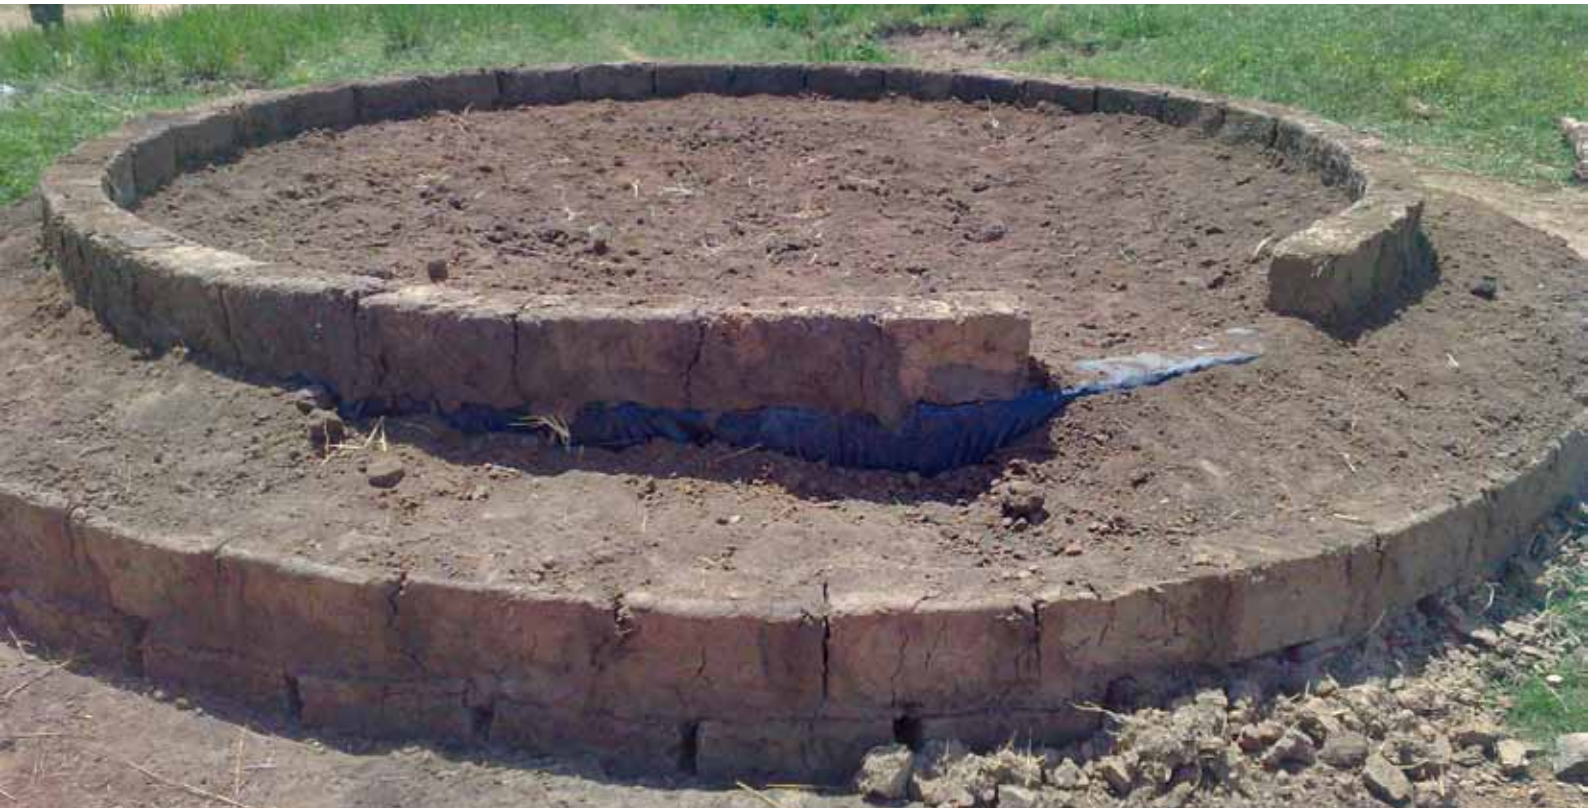
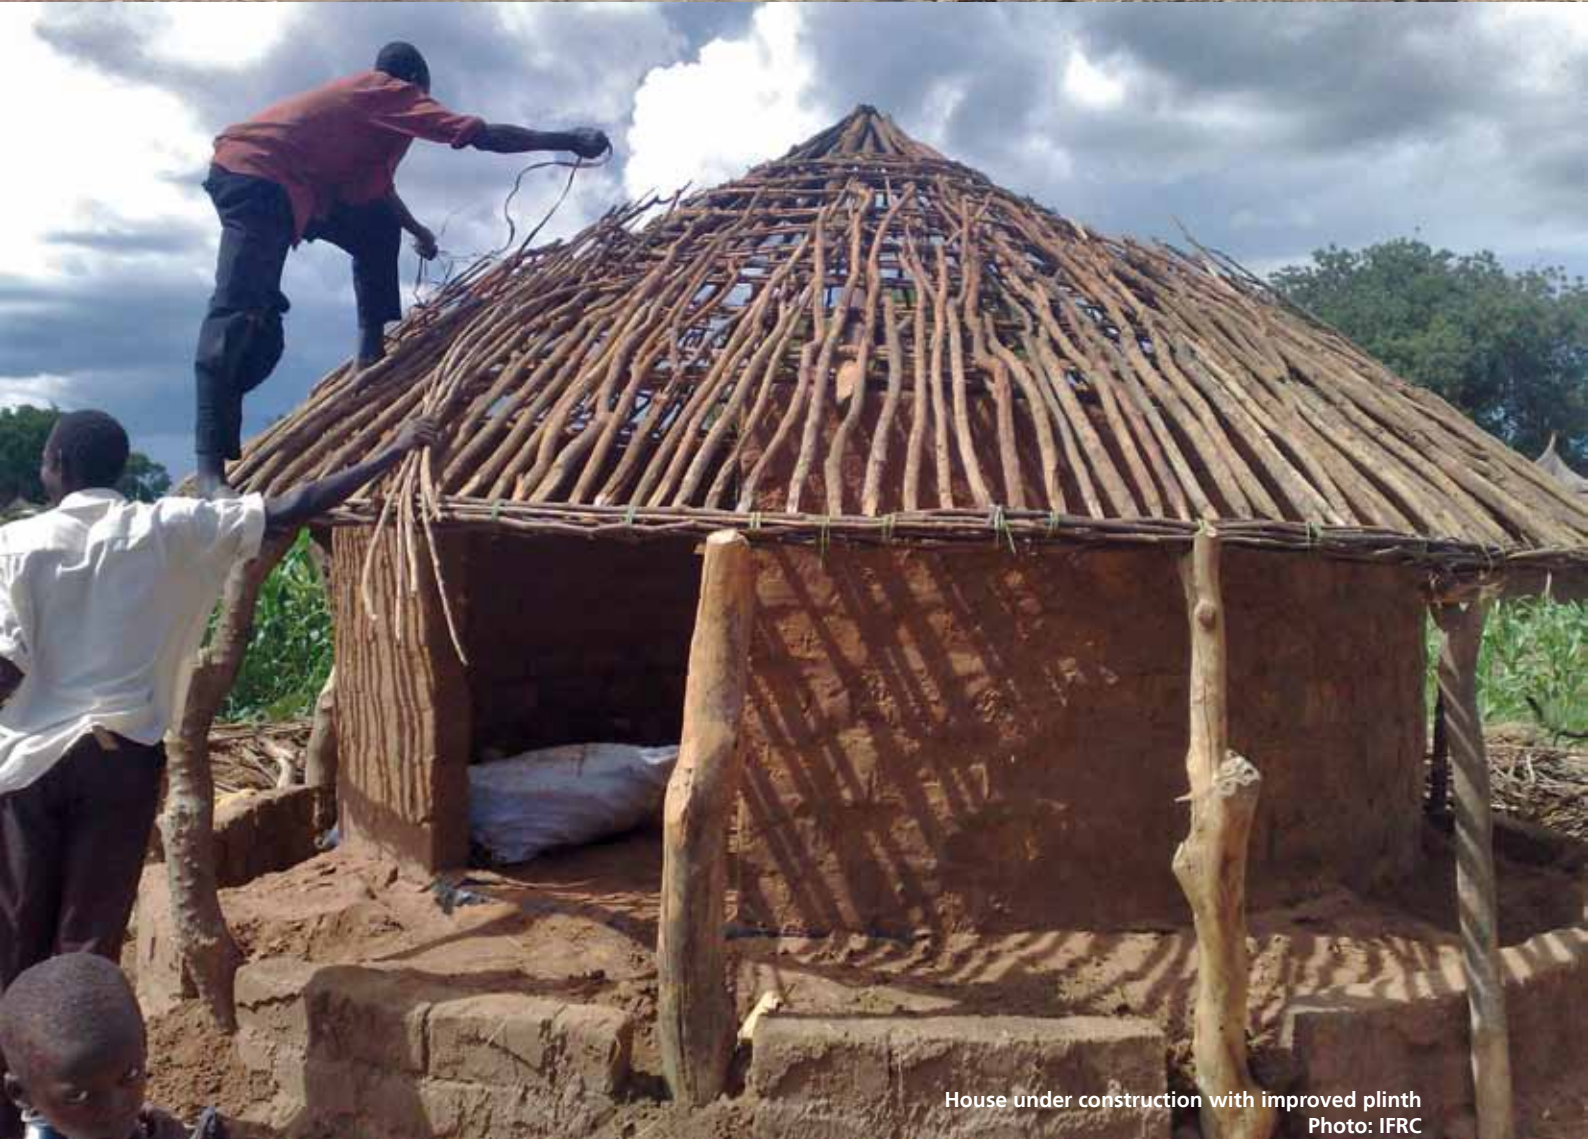
House under construction with improved plinth  
Photo: IFRC

- The house and foundations should be elevated.
- Foundations should be built with a large plinth beam of wattle and daub. This would need to be repaired by house owners after each small flood
- A water proof barrier should be put the foundations to protect the walls and floors which are made of adobe blocks.
- Walls made of sun dried mud blocks should be conical in shape
- Proper materials to build more resistant earth blocks should be identified. Examples are clay from termite hills, and using mud mixed with cow dung to protect against termites.
- Wood in direct contact with the earth should be treated to protect it from termites.

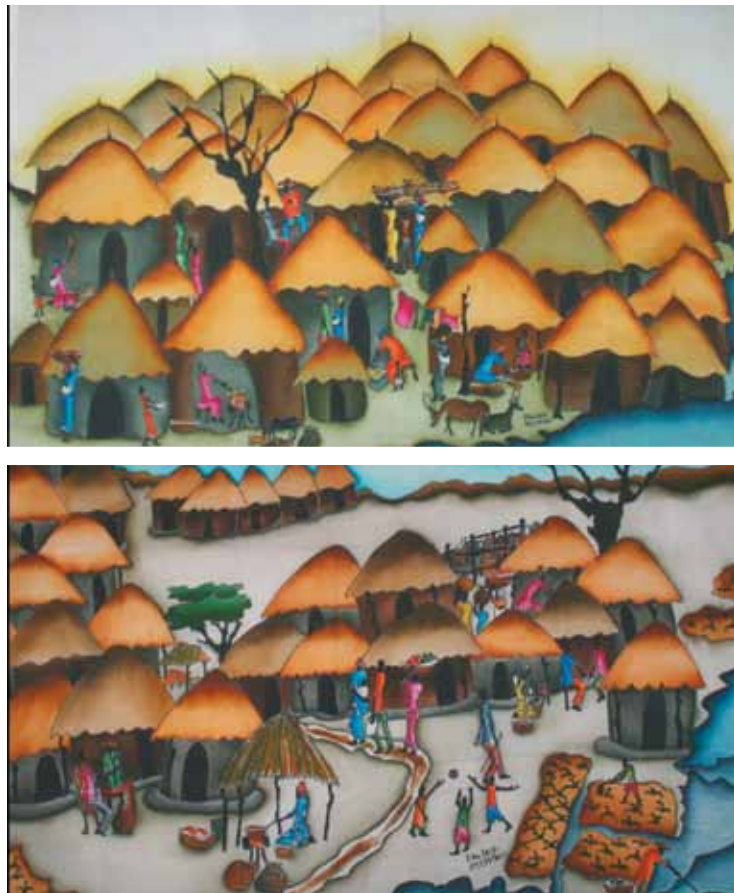
Public information images on proper site planning with space between buildings  
Image credit: IFRC

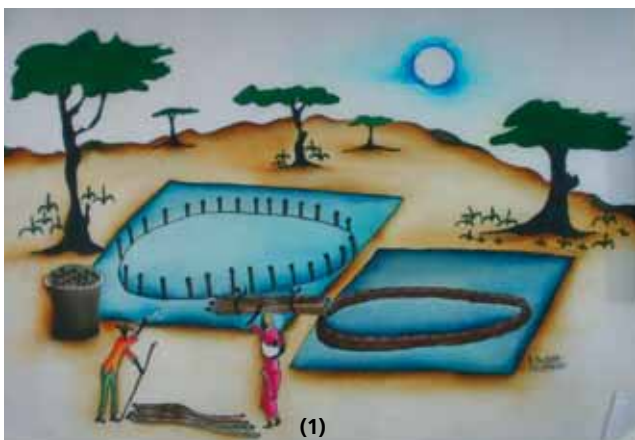
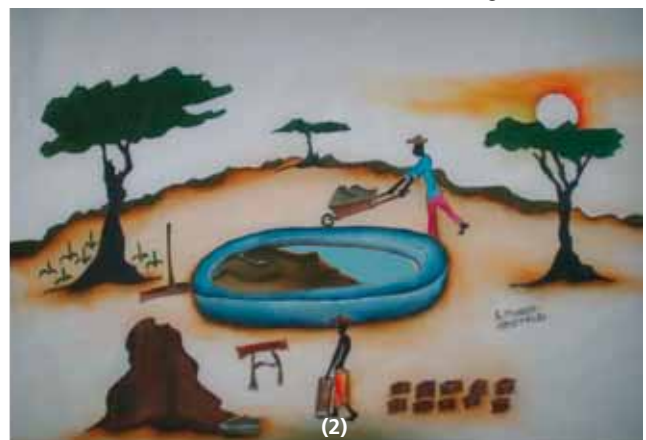
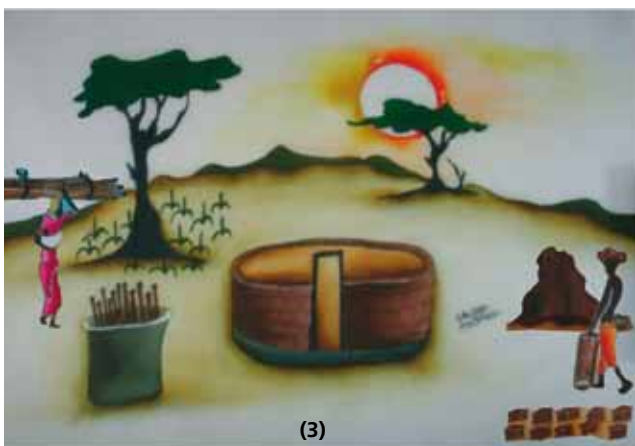
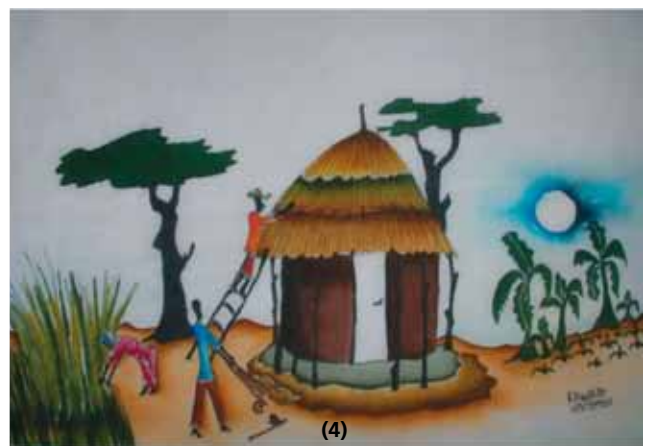
Images from public information posters on building a flood resistant structure: (1) elevate the plinth and put a plastic sheet under the floor (2) fold the plastic sheet over the ground level ring beam (3) build conical walls (4) thatch the roof, render the walls with mud and elevate the area around the house to protect it from flooding  
Image credit: IFRC

showed improved earth construction, and illustrated the following details to protect the house from flooding or termites:
