## B.6 Haiti - 2008 - Flooding

### Case study:

### Distribution, cash and training

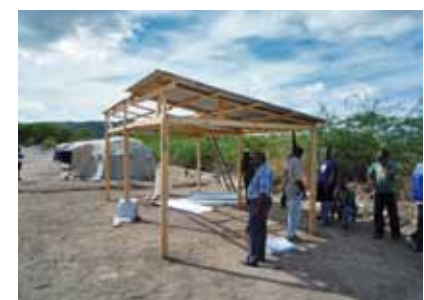
Prototype transitional shelter  
Photo: Joseph Ashmore

A full repair kit given to each family, allowed for construction of a floor slab, a frame and a roof of approx 18m<sup>2</sup>. It was not enough for rendering the walls,

Material	Quantity
Wood (roof) (1" x 3" x 16')	10
Wood (frame) (2" x 4" x 12')	4
Wood (roof) (1" x 4" x 12')	6
Nails (3" 75mm x 3mm)	0.5kg
Nails (roofing) (3" 75mm x 3mm)	0.5kg
Cement	4 bags
Corrugated iron (1.8x0.9m)	16
Flat sheet for roof ridge	1

Families were responsible for masonry and sand. If rocks were not available they need 240 construction blocks (30x20x15 cm).
